STRUCTURAL PERFORMANCE OF DETERIORATED HISTORICAL RC BUILDINGS AT GUNKANJIMA-ISLAND

K. Kabayama¹

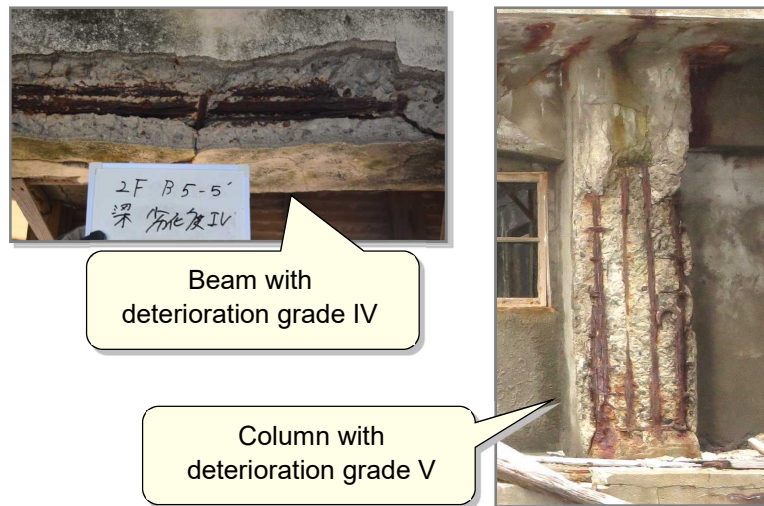
Structural members were classified into column, wall without column, wall with a column, wall with both side columns, and beam. Trained investigators visually judged the deterioration grade (six levels from 0 to V) of each structural member for each building. Figure 3 shows an example of a beam with the deterioration grade IV and a column with the deterioration grade V.

Figure 3. Example of the deterioration grade of structural member

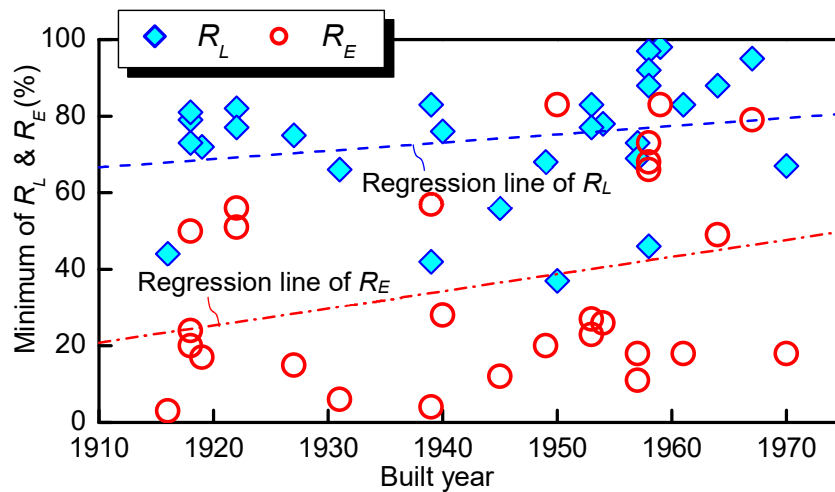
Figure 4 shows the relationship between the built year and the minimum values of R_L and R_E for each building. Each regression line is drawn in the figure. Although it can be confirmed from the figure that both R_L and R_E have a positive correlation with the built year, the variation is large, and it is assumed that other factors such as location on the island and construction status also have a large influence.

Figure 4. Relationship between built year and minimum values of R_L and R_E

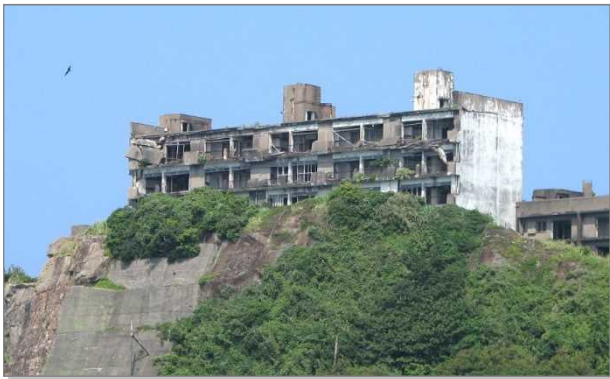
The east facade of Building No. 3

- ◆ Apartment complex for executives of the coal mining company.
- ◆ A four-story reinforced concrete building with a small basement, and it was built in 1959.
- ◆ Built on a sloping cliff, and directly supported by the bedrock.
- ◆ Concrete strength was 18.4 N/mm² in a 2016 survey.
- ◆ The reinforcement was round steel, and the yield strength was estimated to be 294 N/mm².

Figure 5. Exterior photo and specifications of Building No. 3

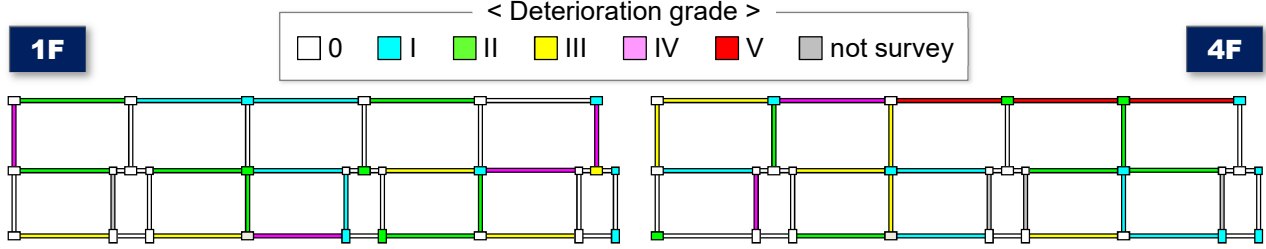
The authors have been conducting a survey on the deterioration grade of structural member in building No. 3 every year since 2015. As an example of the survey results, Figure 7 shows the deterioration grade of columns and beams confirmed in the survey conducted in November 2022, comparing the 1st and 4th floors. It can be found that there are more parts with a higher grade of deterioration on the 4th floor than on the 1st floor from this figure. On each floor, the deterioration grade tends to be higher in the beams than in the columns. It can be confirmed that for both columns and beams, there are differences in the deterioration grade depending on the position of the member.

Figure 7. The deterioration grade of column and beam (Survey in November 2022)

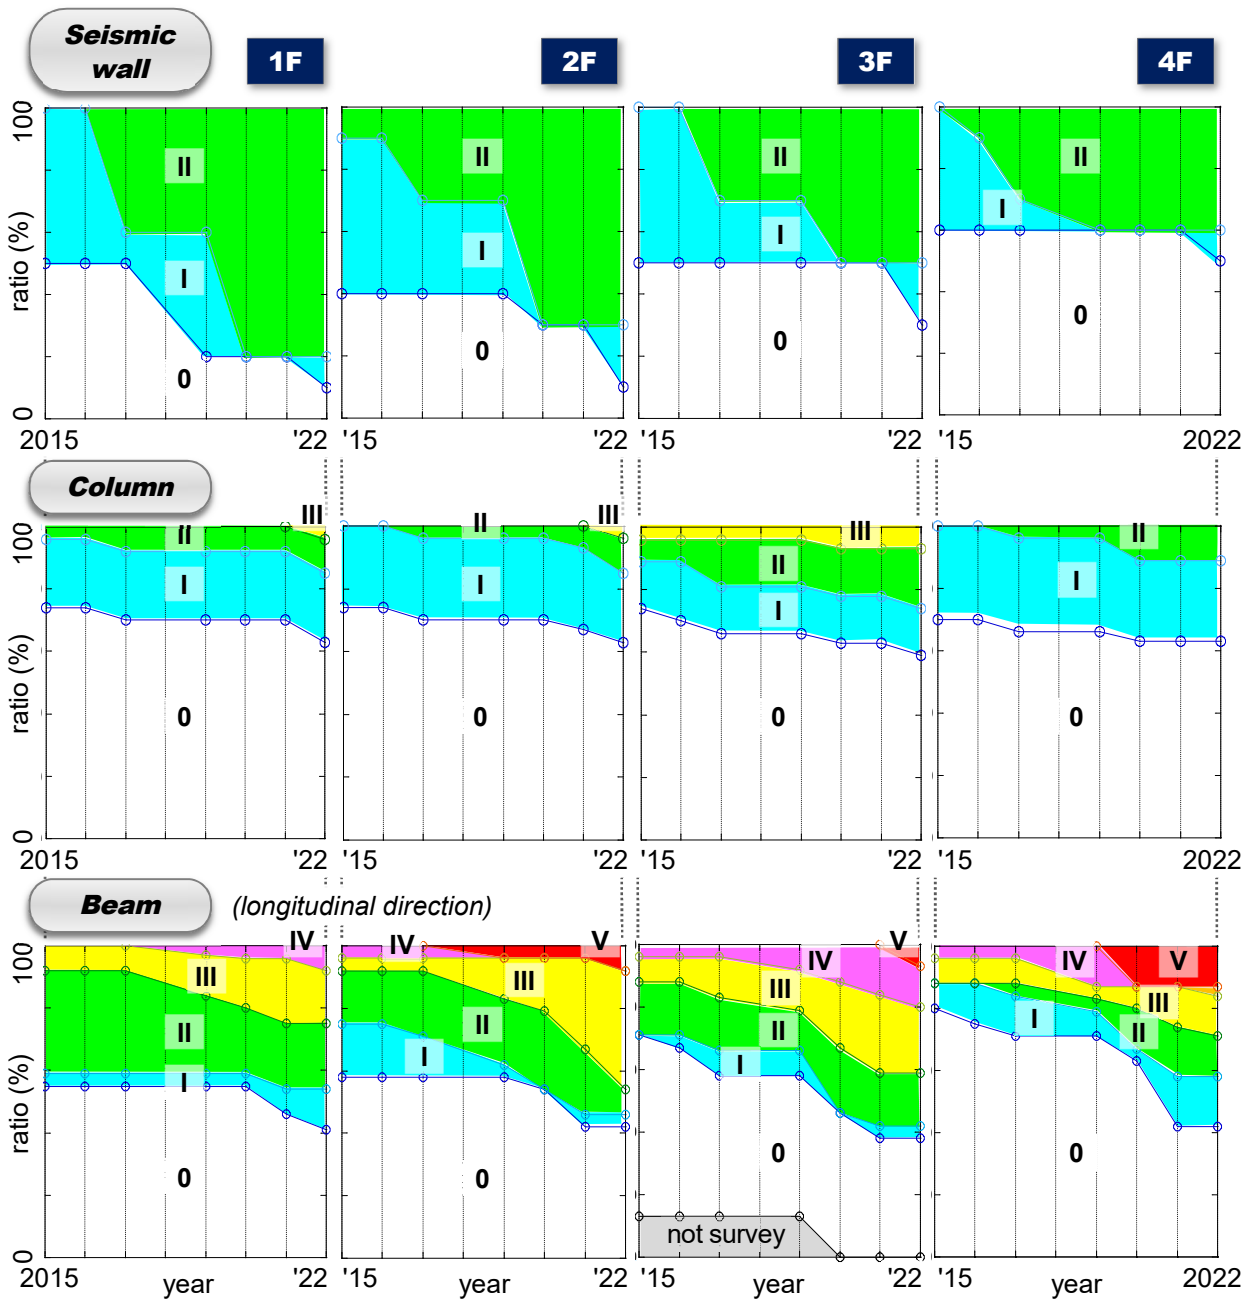
In order to understand the progress of the deterioration grade for each structural member, Figure 8 was created. This figure represents the situation in which the ratio of the number of members related to the deterioration grade changes from 2015 to 2022, in each floor, about seismic walls, columns, and beams (longitudinal direction). It can be recognized from this figure that the deterioration has progressed more remarkably in the beams than in seismic walls and columns. Note that the same tendency applies to the beams in the transverse direction as in the longitudinal direction. The beams are gradually deteriorating on each floor, with the ratio of the deterioration grade IV and V increasing on the third and fourth floors. That is considered as a worrying

situation. On the other hand, although the deterioration grade of seismic walls and columns is milder than that of the beams, it can be found that the deterioration is progressing gradually.

Figure 8. Progress in the deterioration grade of structural member types

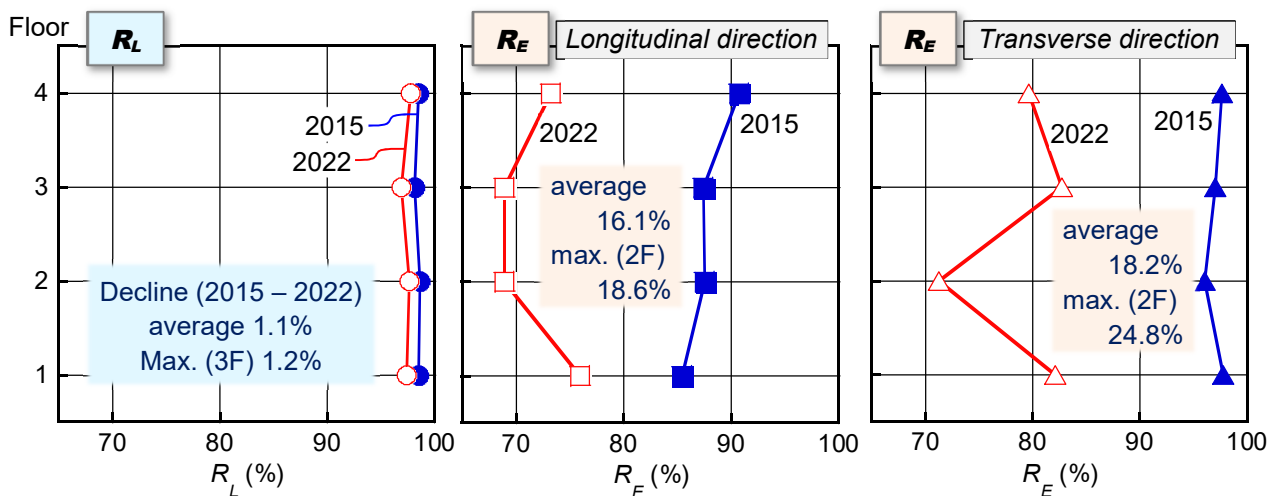
Figure 9 shows the distribution of structural performance remaining ratio (R_L and R_E) in each floor of the Building No. 3, comparing 2015 and 2022. According to the calculation method described in the Section 2.3, the R_L value was determined once for each floor, and the R_E value was determined for each direction of the floor, as shown in this figure.

There was little difference in the distribution of R_L between floors, with a decline of approximately 1% for all floors from 2015 to 2022. On the other hand, the R_E value showed a large decrease in both directions, reaching values of around 10-25%. While the R_L value is mainly calculated based on the deterioration grade of columns, the R_E calculation also takes into account the deterioration grade of beams. The reason for the large decrease in the R_E value was that the deterioration of beams progressed remarkably, as shown in Figure 8.

Figure 9. Distribution and decline of structural performance remaining ratio, R_L & R_E

The effective measures such as repair and retrofiting are urgently required in order to preserve those historically and culturally valuable buildings, including the Building No. 3.

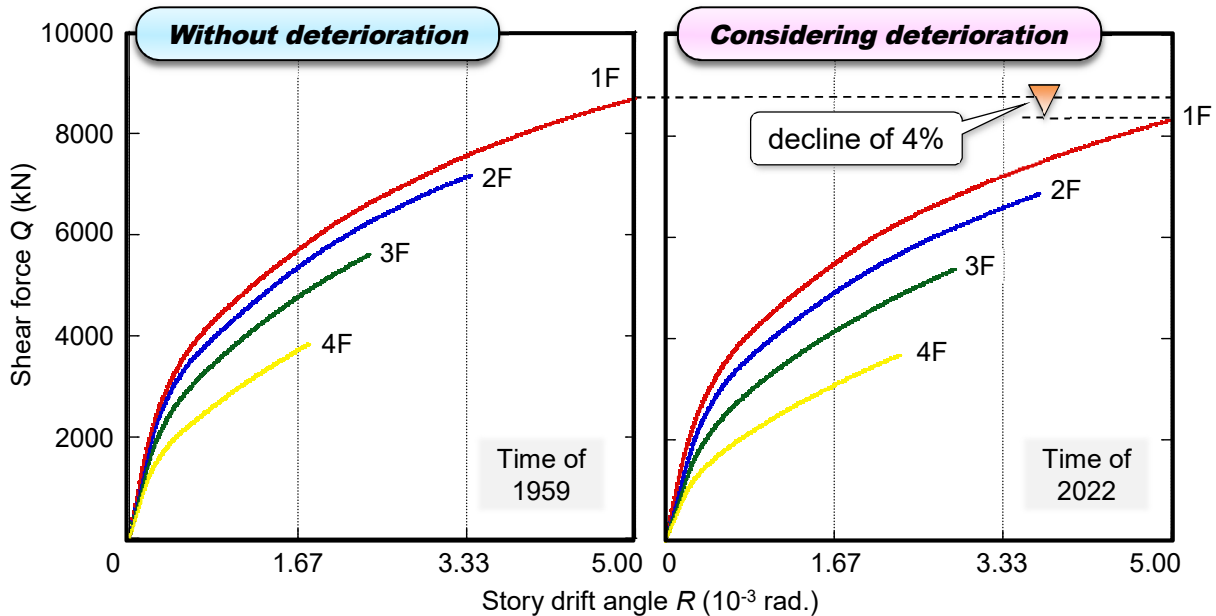
Figure 11 shows the analysis results for a case with no deterioration, which is assumed at the time of construction, and a case that reflects the deterioration in 2022. It represents the relationship between the shear force and the story drift angle of each story when a lateral force is loaded in the longitudinal direction. Considering deterioration of members, the shear force on the first story was reduced by approximately 4% at a story drift angle of 0.005 rad. The effects of column shear failure was not taken into account in this analysis, so improvements should be needed in the future.

Figure 11. Hysteresis curve obtained from pushover analysis in longitudinal direction
