## SEISMIC PERFORMANCE OF RC BUILDINGS AND HIGHWAY BRIDGES DURING THE KAHRAMANMARAS EARTHQUAKES

Y. Demirtaş<sup>1,2\*</sup>, E. Sülev<sup>3</sup>, O. Tunaboyu<sup>1</sup>, A. Bozer<sup>1</sup> & Ö. Avşar<sup>1</sup>

**Keywords:** RC Buildings, Detail Faults, Bridge Damages, Field Observation

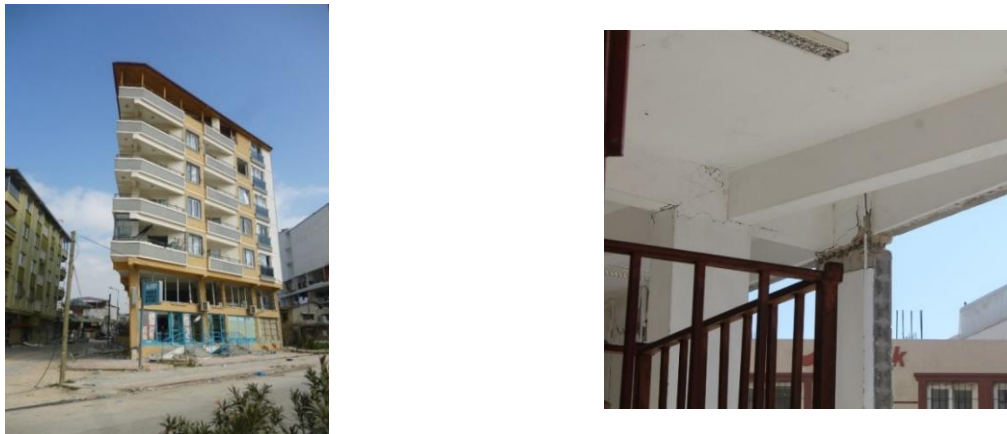
The direct transmission of the story level inertial forces to the foundation through the shortest path during strong ground motion is essential for the sake of the earthquake performance of buildings. Non-orthogonal (Figure 1) and discontinuous moment-resisting frame axes (Figure 2) of cause irregularities in the transfer of inertial forces through the structural system. One of the most common examples for the discontinuous frame was observed at the exterior axes of the RC buildings. The vertical members at the exterior axes are not directly connected with a beam. As the ground story plan area is mostly less than the above story plan areas, the beams are generally applied under the surrounding infill walls without connecting to the vertical members directly. Therefore, a moment resisting frame, at which the vertical and horizontal structural components were connected directly, cannot be achieved in a designed way. The main reason for not connecting the vertical components with beams mainly arises from the architectural concerns because of preventing those directly supported beams to achieve a flat ceiling at the architectural volumes.

*Figure 1. Non-orthogonal axis systems*

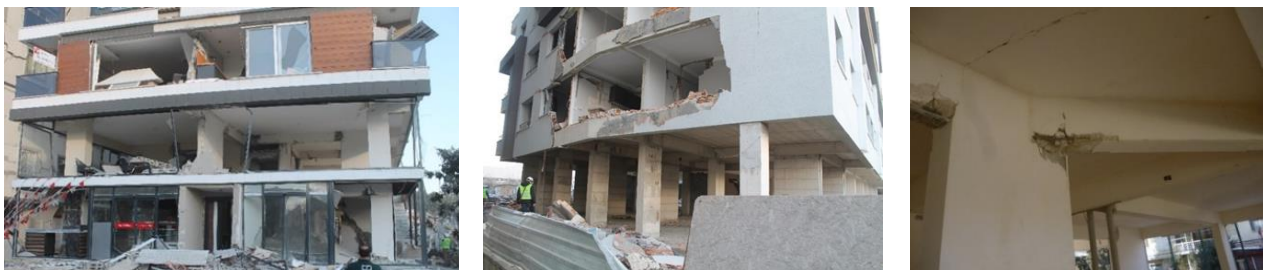
*Figure 2. Discontinuities in the axis system*

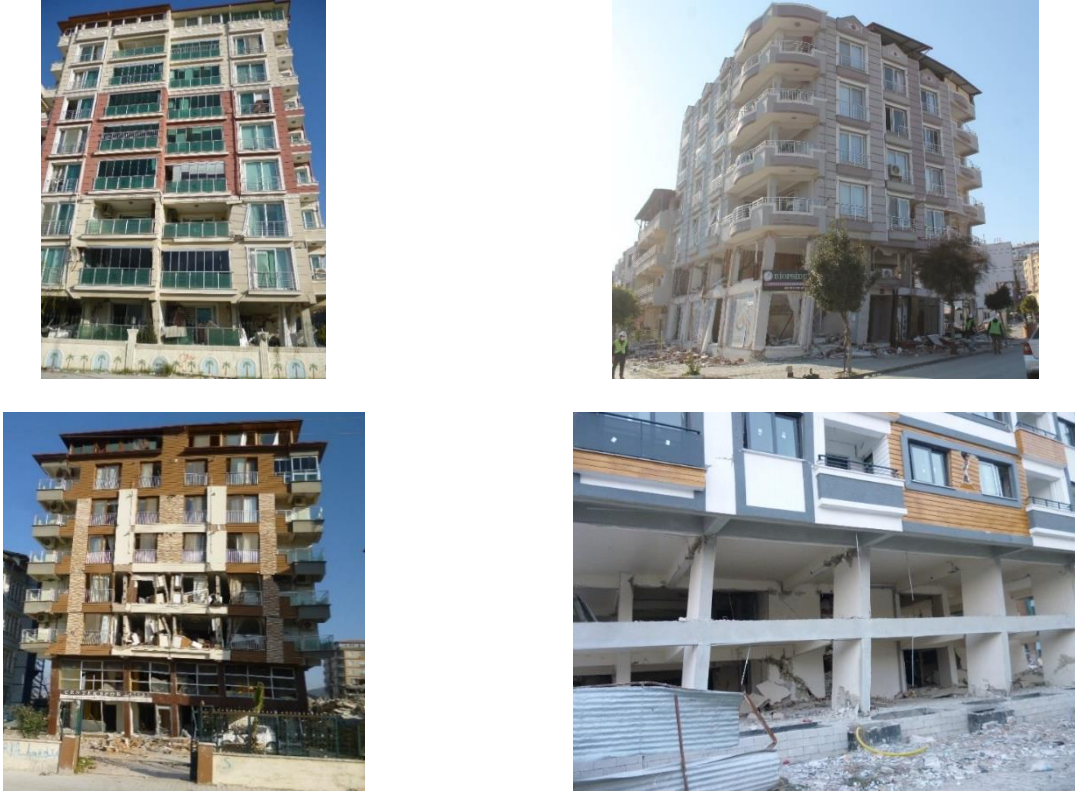
According to TBEC (2018), weak-story irregularity is a type of vertical irregularity in buildings where the behavior factor of the structure is reduced up to a certain limit value, resulting in increased seismic forces in the seismic design of buildings. However, when the limit value is exceeded, the effective shear area of the weak-story needs to be increased, making it necessary to address this irregularity, which arises from the improper distribution of story strength between successive stories. In the case that the vertical load-bearing elements are not discontinuous, the weak-story irregularity is due to the lack of infill walls mostly in the ground story. Observations made in the field (Figure 3) show that the stiffness irregularity between successive stories,

*Figure 3. Weak/soft story mechanisms*

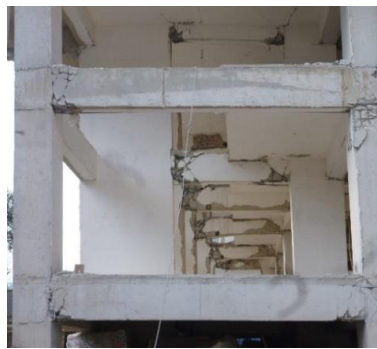
which is also commonly termed as soft story is also affected by a similar mechanism. TBEC (2018) controls the formation of soft story irregularity by limiting the ratio of the drift ratios of the successive stories. Therefore, it is the responsibility of the design engineer to consider the contribution of each structural and non-structural component in the story stiffness. Therefore the stiffness contribution of the infill walls should be included in the structural model in order to calculate the story displacements more precisely. In the field observations, beam damages were observed, which is estimated to be due to the sudden stiffness change that occurs when the slabs are continuous in one part of the beam length and not in the other part (Figure 4).

*Figure 4. Slab discontinuities*

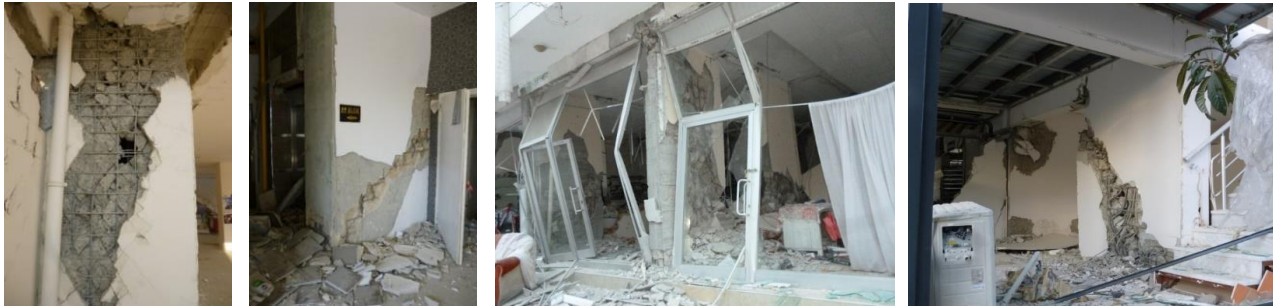
It has been observed that the shear walls are exposed to excessive shear forces and lose their structural integrity as a result of insufficient use of the shear walls in both directions (Figure 5). According to TBEC (2018), shear forces on shear walls are obtained by proportioning the shear plastic moment capacity to the moment demand, taking into account the overstrength coefficient and dynamic amplification coefficient according to the capacity design principle. On the other hand, in field observations, brittle shear damages were

observed in the shear walls by reaching their shear capacities before they reach their plastic moment capacities (Figure 5).

*Figure 5. Shear failure of shear walls*

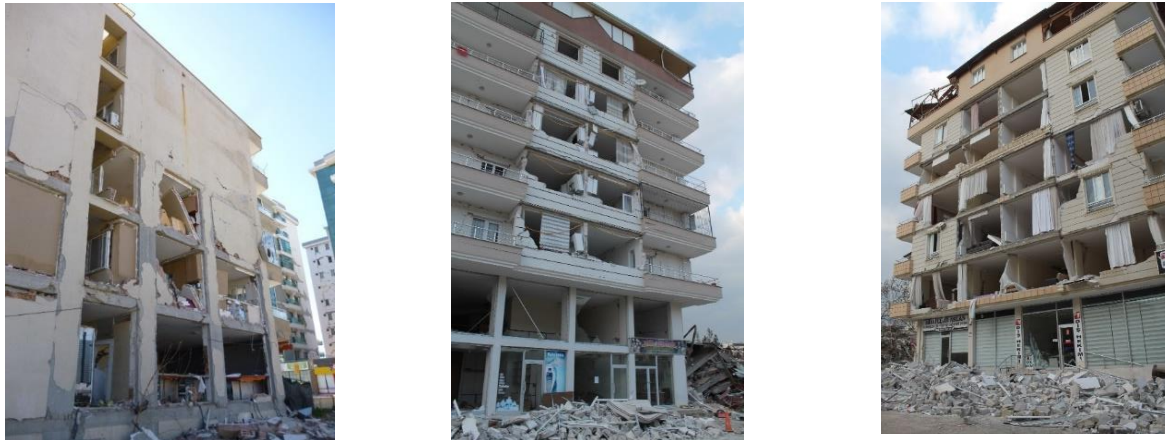
Buildings that lack sufficient stiff elements in both directions and have irregularities in the stiffness between adjacent floors are exposed to significant relative lateral displacements when using ribbed slab, leading to increased seismic damage in structural components. Additionally, non-structural elements such as infill partition walls and cladding panels are observed to topple out of their planes due to these large lateral movements. Ribbed slab, in such cases, exacerbates the damage to both structural and non-structural elements, necessitating careful consideration in the design of RC buildings having ribbed slabs Figure 6.

*Figure 6. Out-of-plane tipping of exterior infill walls in ribbed slab systems*

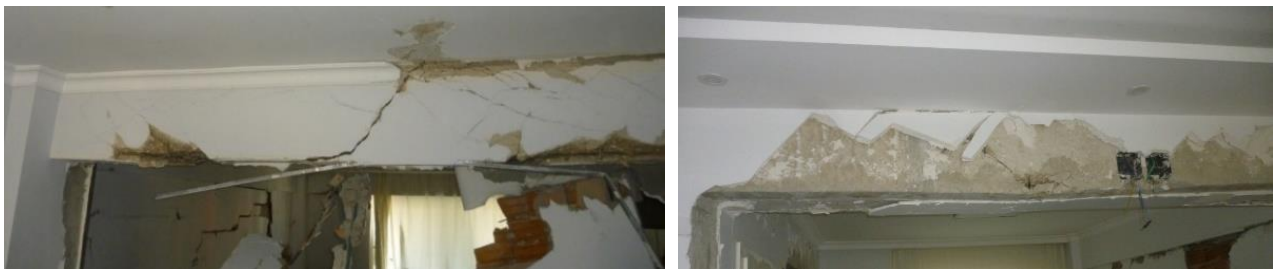
As can be seen in Figure 7, shear damage was observed close to the mid span of the beam. The shearing demands in the transition region should be taken into account when determining the stirrup spacing from the end regions to the mid region. Generally, large shearing demands occur in the short beams between the stiff vertical members (e.g. Beam between the strong axis of two shear walls.). If it is not equipped properly and cross reinforcement bundles are not used in the design, severe shear damages are inevitable (Figure 8).

*Figure 7. Shear damage near the mid span of the beam*

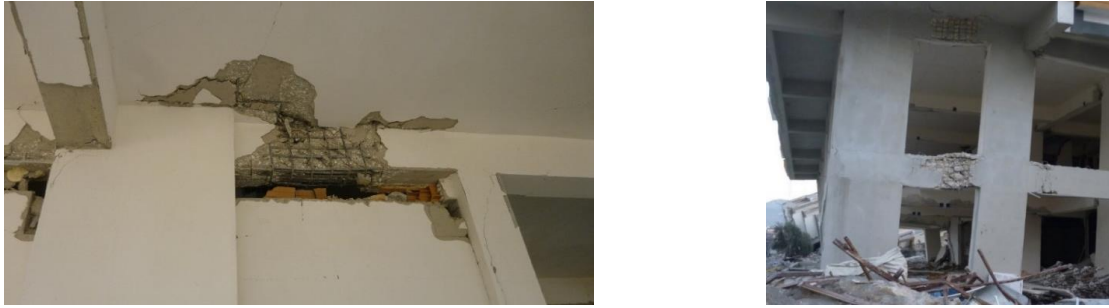
Figure 8. Shear damage of short beams

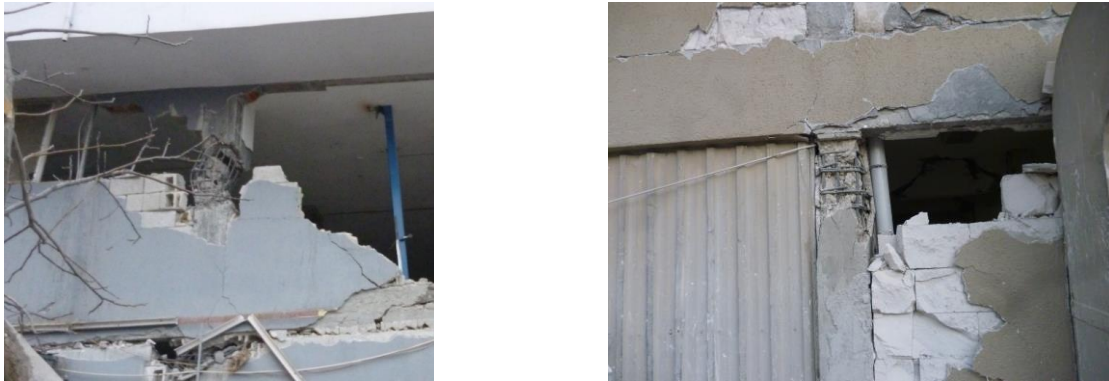
Captive column damages were frequently encountered (Figure 9). According to TBEC (2018), in cases where captive column formation cannot be prevented, the shear forces obtained by dividing the total plastic moment capacities at the lower and upper ends of the column section by the column net height should be taken into account in design. Otherwise, if the column shear demands are larger, which is the case in short and captive columns, than the column shear capacity consistent with the flexural capacity of the columns, brittle type of column shear failure is inevitable before the formation of plastic hinges at the column ends.

Figure 9. Shear damage on the captive columns

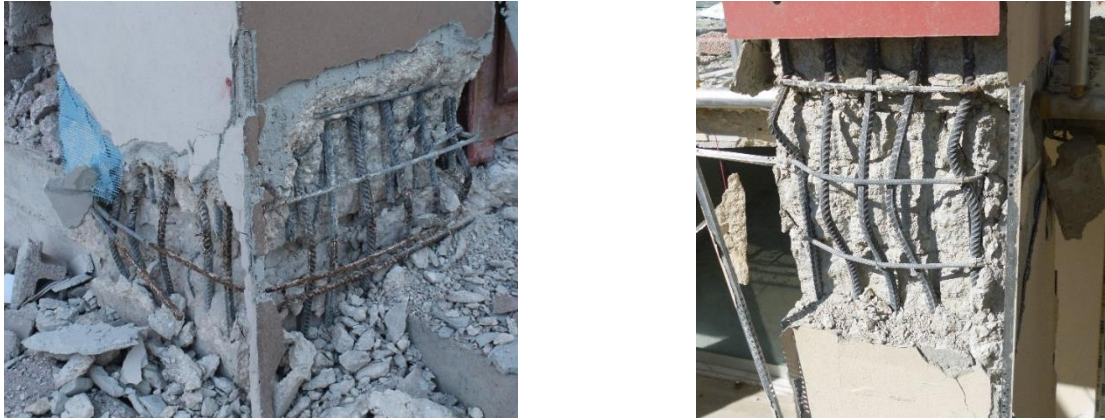
Even if the distance between the stirrup arms is sufficient to meet the column shear demands, the horizontal distance between the stirrup arms and/or crossties should not more than 25 times the stirrup diameter, according to TBEC 2018. In Figure 10, it is seen that the longitudinal rebars are confined with only single stirrup, which can only restrain the corner rebars. As required by most of the previous and current seismic design codes in Türkiye, internal rebars should be confined by additional crossties or stirrups other than the outer single stirrup. Otherwise, upon the crushing of cover concrete, internal bars can deform and buckle causing loss of integrity for the column cross section.

*Figure 10. Large spacing between stirrups*

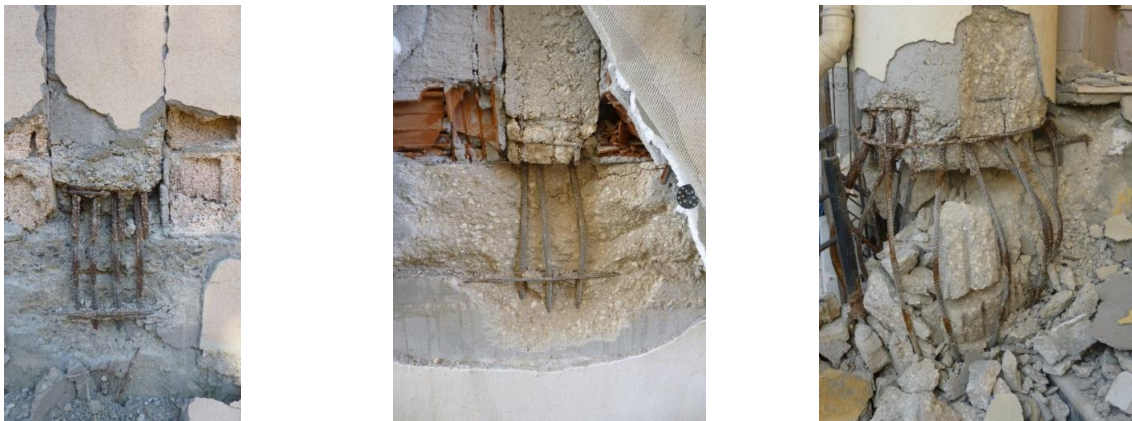
According to TBEC (2018), the transverse reinforcements used in column confinement zones should be continued in the foundation or overhead beam along a height not smaller than the minimum size of the column. The transverse reinforcements in the shear wall end regions must be continued inside the foundation for a height not less than 300 mm and shear wall thickness. However, incorrect applications were observed in the application of the transverse reinforcements in the vertical structural members through the foundation due to the difficulty of implementation, lack of knowledge and most likely due to lack of audit. As can be seen in Figure 11, transverse reinforcements were not properly and adequately applied and it was observed that the longitudinal reinforcements buckled both at the lower end of the column and at the foundation level. This situation was observed especially at the lower points of the exterior and corner columns. Such columns become critical since there is no transverse reinforcement to hold the longitudinal reinforcements in this region when the cover concrete of the foundation under the column or the beam above the column is crushed and disintegrated.

*Figure 11. Discontinuity of transverse reinforcement within the foundation*

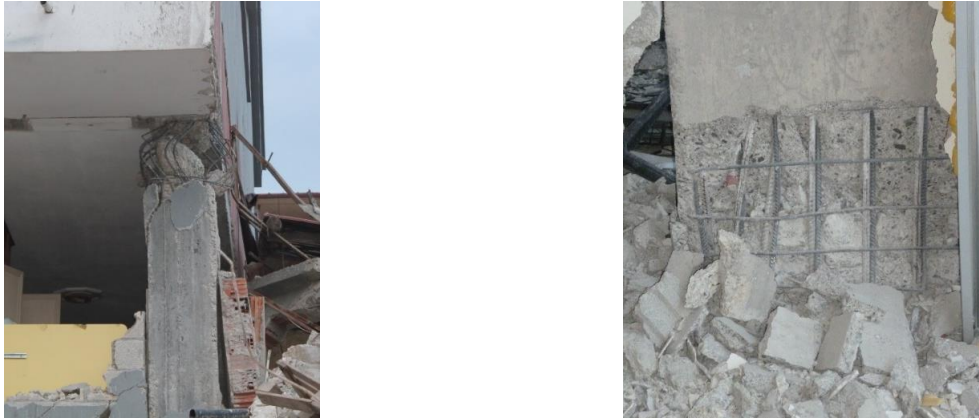
The use of transverse reinforcement with minimum required diameter, spacing and detailing should be applied in the confinement regions to satisfy the high ductility requirement for columns. The spacing between the transverse reinforcement directly affects the ductility of the section and the compressive strength of the concrete. Special confinement zones should be created at the lower and upper ends of the columns. Thus, it is aimed that the concrete in the core region of the column will show a more ductile behavior with the confining effect. In Figure 12, it is seen that a suitable confining zone is not provided by the transverse reinforcement as described in TBEC (2018). As a result, it is seen that the core concrete is crushed followed by the buckling of the longitudinal reinforcements in the confinement regions at the lower and upper ends of the column.

*Figure 12. Lack of stirrups or crossties in the confinement zones*

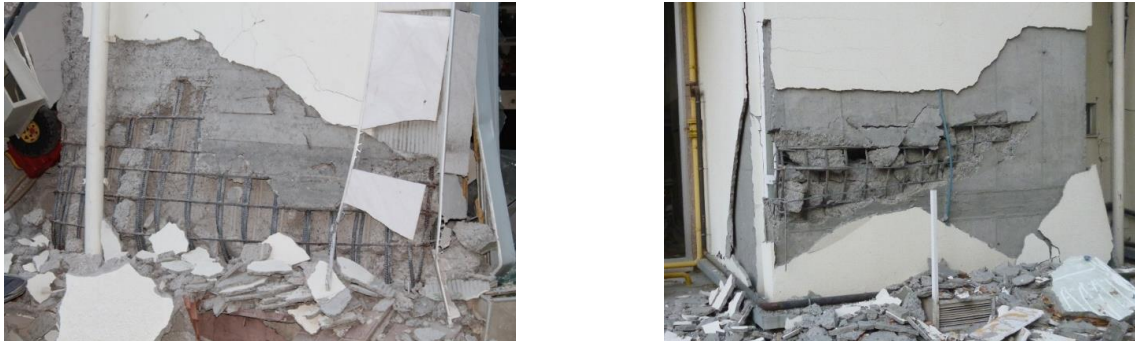
The longitudinal reinforcements should be confined by using closed stirrups and crossties at the end confined regions of the shear walls as in the case of columns. In addition, in order to preserve the integrity of the shear wall section, there must be a certain number of special earthquake crossties per square meter depending on whether it is at the critical shear wall height or not. As can be seen in Figure 13, the horizontal and vertical reinforcements in the shear wall have been disintegrated and buckled due to the application of insufficient number of crossties or not applying at all, thus losing the integrity of the shear wall section. As a result, the most critical structural component that resists the seismic demands caused by the earthquake is exposed to severe damage, which can lead to unrecoverable damage or total collapse of the structural system.

*Figure 13. Lack of crossties in the shear wall*

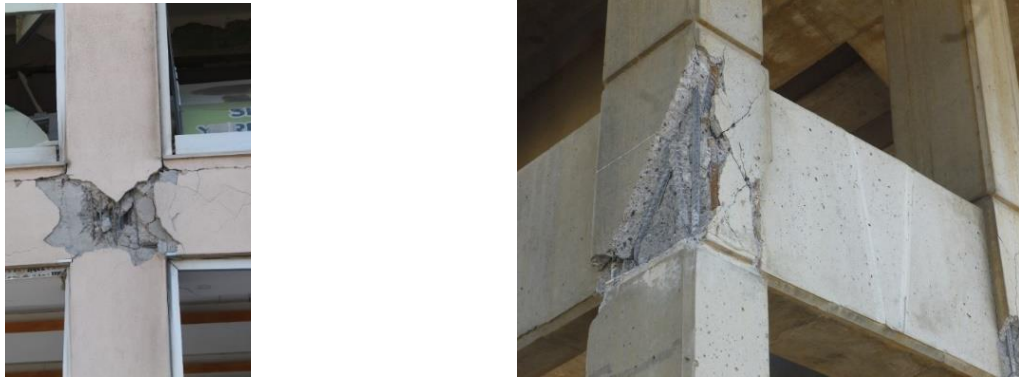
According to TBEC (2018), a certain amount of the transverse reinforcement calculated for the confinement zone of the column ends should be applied to the beam-column joints as well, depending on the confinement of the joint region by the beams. This requirement has been present not only in the current earthquake code, but also in previous earthquake regulations since 1975 (TEC, 1975). Even in newly constructed RC buildings, severe joint shear damage was observed due to lack of transverse reinforcement in the joint panel (Figure 14). It is seen that only stirrups are used as transverse reinforcement in the beam-column joints of the newly built RC buildings. As also observed in the column end regions, if additional stirrups or crossties are not used in the joint region, the longitudinal rebars buckle upon the crushing of joint cover concrete (Figure 15). Because buckling of internal rebars cannot be prevented by a single exterior stirrup (mostly 8mm diameter bars) with its flexural stiffness. Therefore, adequate amount of transverse reinforcement should be placed in the joint regions, just as in the column confinement regions, by applying additional stirrups and crossties, taking into account the maximum spacing limit of  $25\phi_{\text{stirrup}}$  between the confined longitudinal rebars.

*Figure 14. Not using transverse reinforcement in beam-column joints*

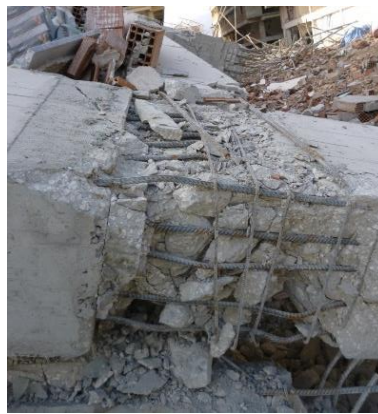
*Figure 15. Lack of cross-ties in beam-column joints*

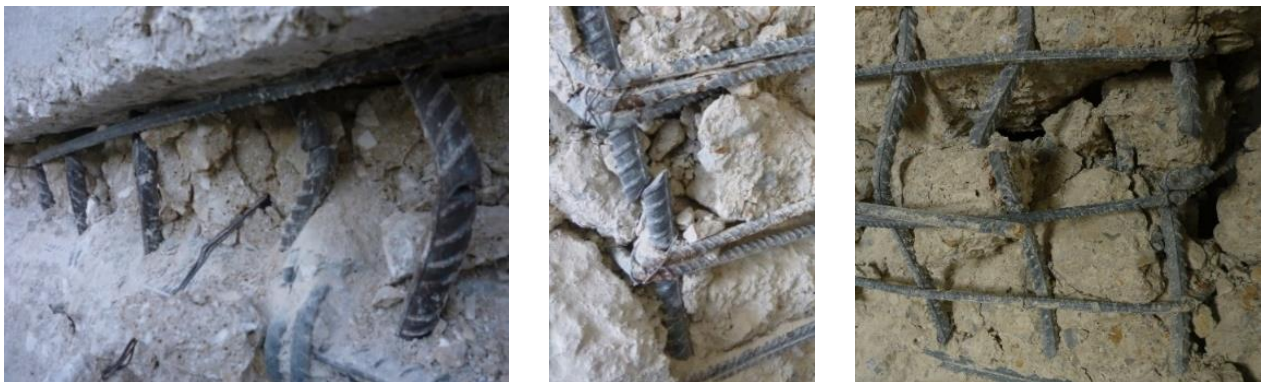
Ductility of the reinforcing steel is one of the most important parameters in obtaining a ductile response for RC buildings. However, in the field inspections made in the damaged buildings, it was observed that the reinforcements fractured in a brittle manner in the critical sections of many reinforced concrete elements (Figure 16). A horizontal or inclined fracture surface was observed in such brittle reinforcement rebars. It is thought that brittle fracture occurs as a result of buckling of the reinforcement under pressure and low cycle fatigue effects due to the reverse cyclic nature of the earthquakes. The reason for such response is due to the combined effect of high gravity loads with the high vertical component of ground motions. Another reason for brittle reinforcement fractures is thought to be the deficiency in material properties such a high carbon content of reinforcement bars.

*Figure 16. Fracture of reinforcement rebars*

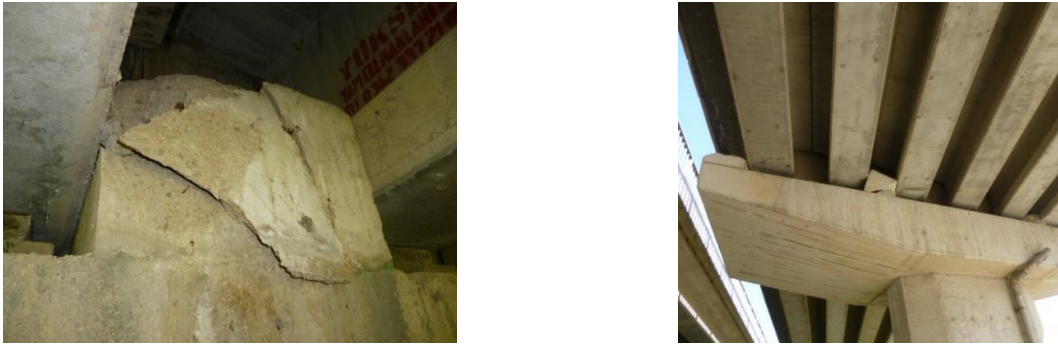
Shear keys restrain the displacement of the bridge superstructure in both longitudinal and transverse directions at the abutments and piers during seismic events. Most of the shear keys were damaged up to failure as a result of pounding induced effects between superstructure and shear keys. Shear keys are considered to be the fuse elements for the bridge and it is acceptable for them to be damaged to protect the substructure components. It is important to carry out the structural repair of the damaged shear keys after the earthquake or to remove them completely and to make new ones in order to restrain the transverse displacement of the bridge superstructure in the future earthquakes. Figure 17 shows different levels of damage in shear keys.

Figure 17. Damaged shear keys

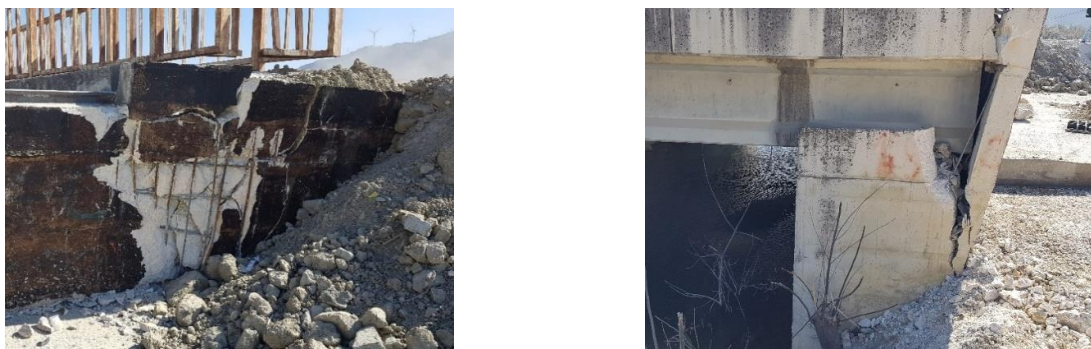
Due to the displacements of the bridge superstructure in the longitudinal direction, pounding takes place between the superstructure and abutment back wall, which can expose to severe shear damage during the seismic events (Figure 18). Although the seismic damage imposed on the shear keys or abutment back walls can impair the functionality of the bridge and result closure of the bridge to traffic, the seismic repair or replacement of such fuse elements can be conducted to recover the functionality of the bridges.

Figure 18. Back wall damages caused by pounding between the abutment and superstructure in the longitudinal direction

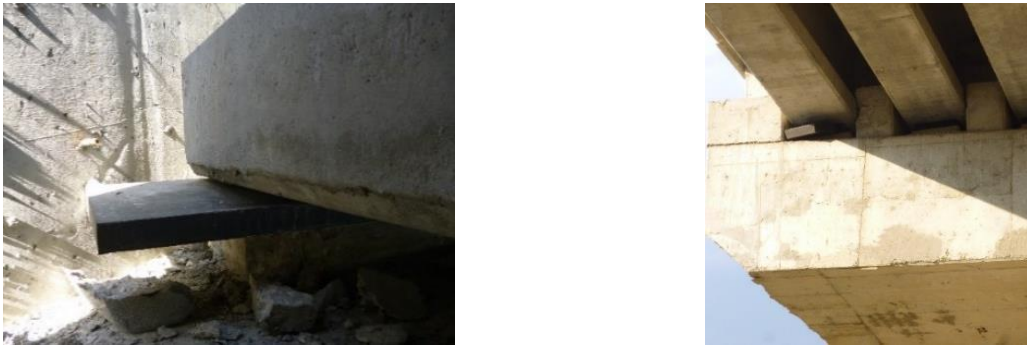
In the highway bridge application practice in Türkiye, the elastomer bearings that separate the superstructure and the substructure are placed directly in between without using any connections. Therefore, friction force between the elastomer bearings and the concrete surfaces is the only resisting force to hold the elastomer bearings at their locations. However, during the lateral movement of the superstructure as well as the uplift of the superstructure due to vertical component of ground motions, dislodgement of elastomer bearing took place during this earthquake event (Figure 19).

Figure 19. Displacement of elastomer bearings

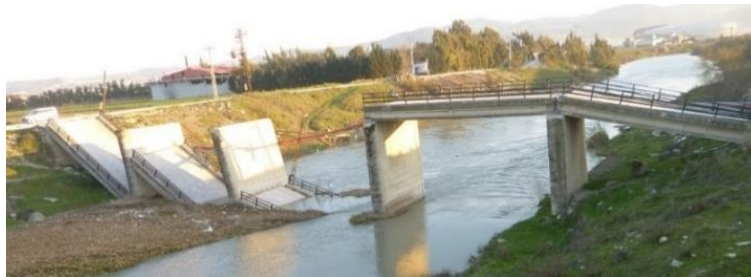
One of the highway bridges, which is already out-of-service before the earthquake, was failed due to deck unseating as a result of insufficient seat length( Figure 20). The original condition of the bridge before the earthquake is unknown. The insufficient seat length at the abutments and piers is the main cause for the bridge failure.

Figure 20. The unseating of superstructure of a bridge, which is out-of-service on the Hatay Hospital road, Coord: 36.27212, 36.20774
