HEAVY DAMAGE TO INFILLS IN THE FEBRUARY 2023 KAHRAMANMARAS EARTHQUAKES: REASONS AND POTENTIAL SOLUTION

M. Marinković¹, C. Butenweg²

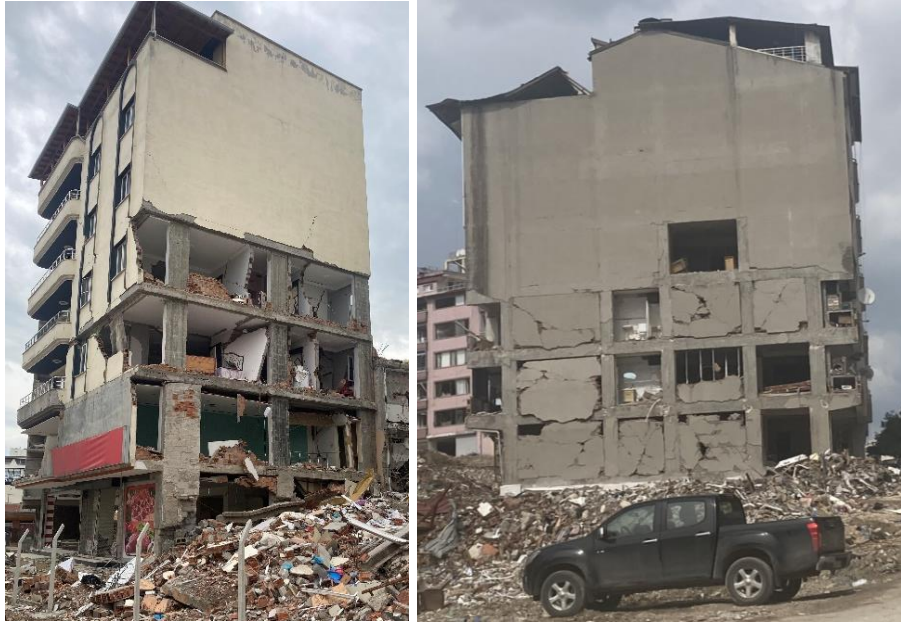
Figure 1. Damage and OOP collapse of infills in RC buildings without structural damage (Turkey 2023)

seismic forces, these masonry infills, often constructed in direct contact with the surrounding RC frame, become involved in in-plane (IP) actions due to frame deformation. In addition to IP loads, masonry infills also experience out-of-plane (OOP) seismic forces caused by acceleration acting perpendicular to the wall plane. These seismic influences, originating from two perpendicular directions, can affect masonry infills either individually or simultaneously, depending on the seismic conditions. Consequently, this phenomenon contributes significantly to the substantial damage suffered by infill walls (Fig. 1), a pattern observed in all seismic events of medium to high intensity.

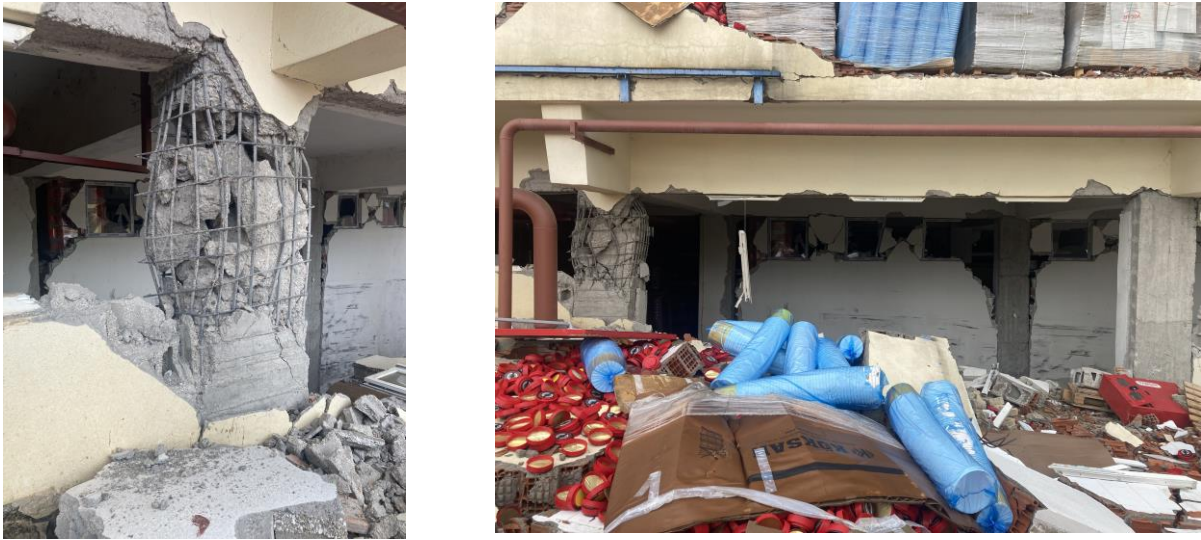
Figure 3. "Short column" effect due to interaction between RC column and partial height infill

Instances of the "short column" effect (Figure 3), arising from the interplay between columns and partially infilled masonry panels, have been observed. In such cases, the interconnection of the masonry infill with the RC column, combined with restricted deformations of the column along its height, resulted in an escalation of shear force in the "free" section of the column. Despite the inclusion of 15 cm spaced and 135-degree hooked ties, shear cracks emerged. A notable limitation was the insufficient reinforcement of the RC column, which solely featured external ties, while the presence of internal ties was anticipated.

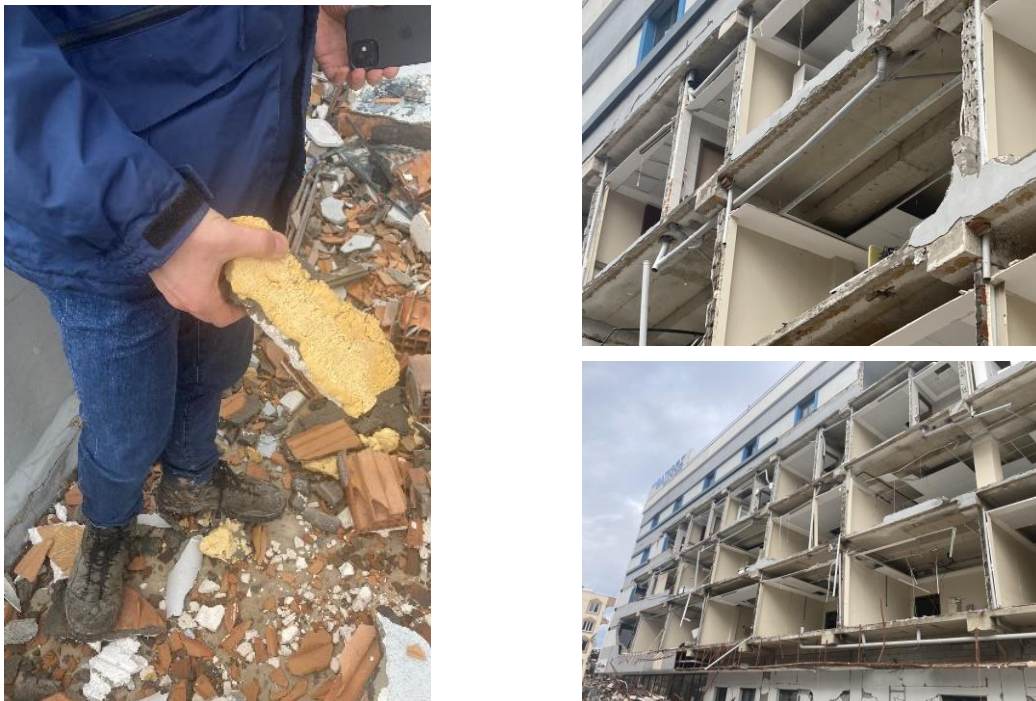
Figure 4. Hospital in Iskenderun: Damage and collapse of infills

Instances of inadequate performance in non-structural elements, such as infill walls and brick façade walls within RC frame structures, have been noted. During the earthquake, infill walls experienced both in-plane and out-of-plane loading, leading to a substantial decrease in the load-bearing capacity of the infill under out-of-plane loading. Additionally, there was a loss of proper contact between the frame and the infill. The utilization of polyurethane foam at the connection between the infill and the RC frame (Figure 4) often caused damage

and collapse of the infill. It is noteworthy that this method of connecting infill to the surrounding RC structure has gained significant popularity across numerous construction sites, despite the evident drawback that polyurethane foam does not establish a durable connection between the wall and the structure. Consequently, any perpendicular acceleration to the wall plane can result in the infill becoming dislodged in an out-of-plane direction. In this case (hospital in Iskenderun – Figure 4), failure of infill walls caused the hospital to be mail functional although building did not have big structural damage.

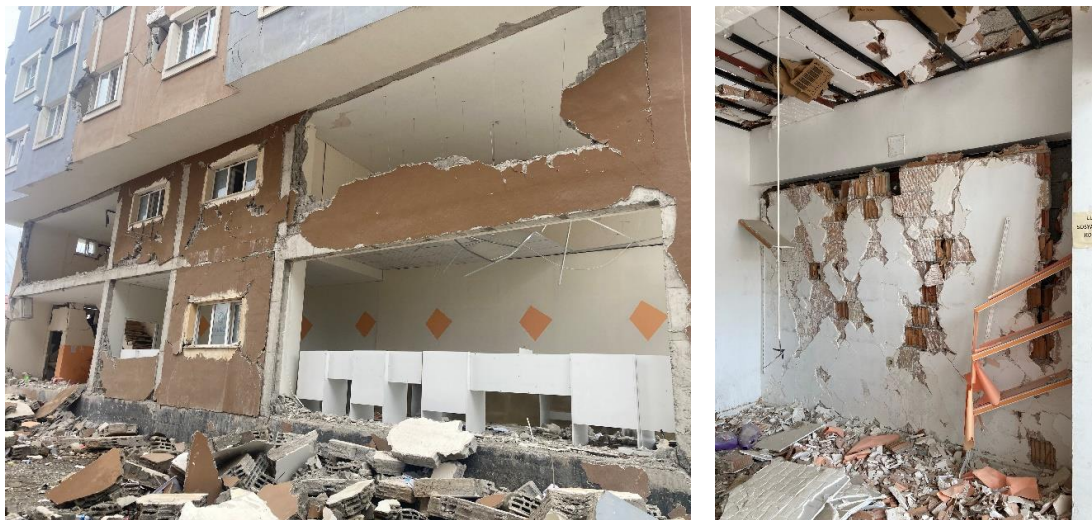
Figure 5. Damage of infill walls made of hollow concrete blocks and hollow clay blocks.

It's crucial to emphasize that the nature of damage was not dependent on the type of masonry units used, as most infill walls exhibited similar forms of damage, including diagonal cracks, and in numerous cases, out-of-plane (OOP) collapse (Figure 5 and Figure 6a). In addition to the risks associated with the damage and fracture of infill walls, which pose a substantial threat to the safety of building occupants, another significant concern was that the collapse of these walls obstructed staircases and other evacuation routes, both inside and outside the building. The fracture of infill walls emerged as a notable impediment to the reoccupation of the building. The area around staircases also serves as an example of non-structural elements in the building that were frequently damaged (Figure 6a).

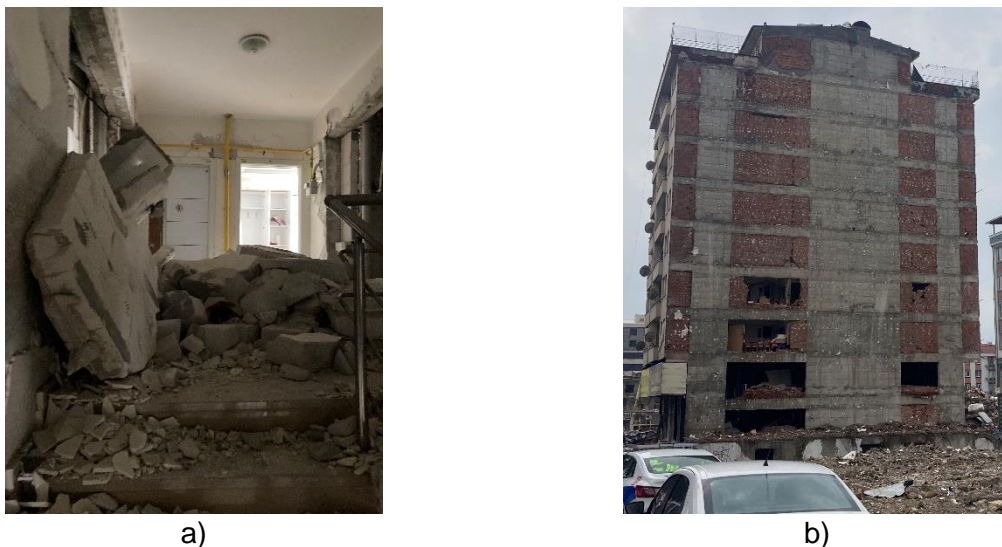
Figure 6. a) AAC infill damage blocking escape routes at stairwells and b) damage and collapse of infill walls on the lower stories

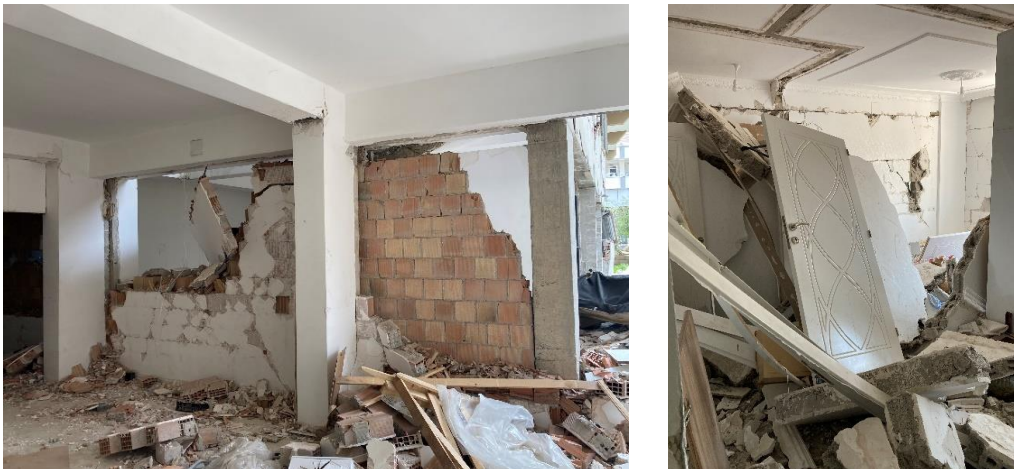
Figure 7. Infill damage inside the buildings
