BUILDING SEISMIC RESILIENCE FOR NEW ZEALAND - PAST, NOW AND FUTURE

Lianyan Li¹, Alice Chang-Richards², Megan Boston³, Ken Elwood², & Carlos Molina Hutt⁴

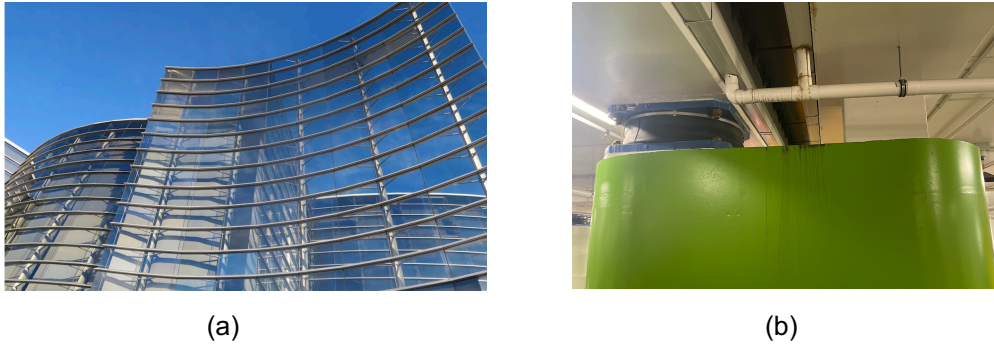
Base isolation is a passive structural control technique that separates the building from the ground, effectively preventing the direct transmission of earthquake ground motions into the structure, thus protecting the building's structural integrity. Prior to the devastating 2010/2011 Canterbury earthquakes, only one building (Christchurch Women's Hospital) utilised base isolation and expectedly did not suffer any damage during the earthquakes (Buchanan *et al.*, 2011). Twelve years since the February 2011 earthquake, Christchurch CBD now has a total of 16 buildings with base isolation installed. A number of newly constructed and retrofitted steel buildings also have base isolation bearings. One prominent example is the retrofitted Christchurch Art Gallery, as depicted in Figure 3. Its base isolation system was implemented by placing the underground portions of the

building on flexible bearings or isolators. These isolators are designed to absorb and dissipate seismic energy during an earthquake, thus reducing the transmission of ground motion to the structure and protecting the valuable artwork.

Figure 3. Christchurch Art Gallery: (a) Global view; (b) Base isolator in the underground

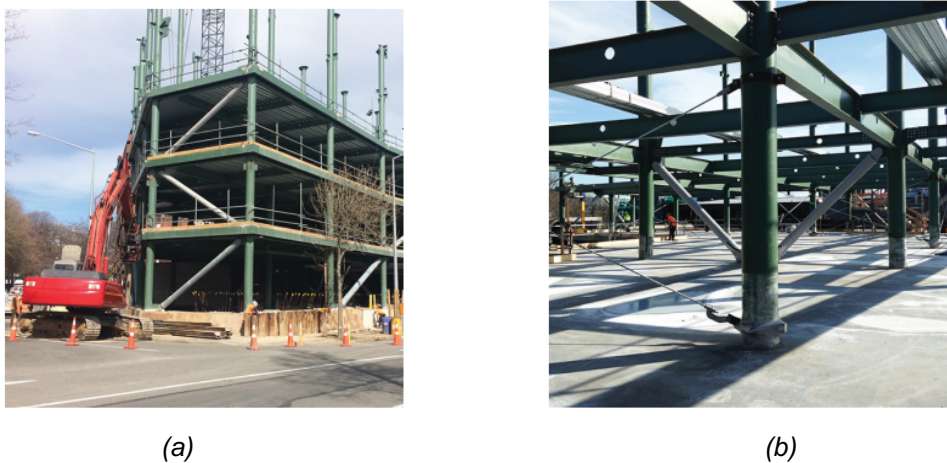
Furthermore, steel buckling restrained braced (BRB) frames are also incorporated in the building repair and rebuilding efforts. BRB effectively provide strength and ductility to the structure, and its braces can prevent buckling and maintain their load-carrying capacity even under severe earthquake shaking. For example, the BRBs adopted by PwC Centre (see Figure 6) can yield the internal steel core in tension and compression with the outer steel casing, preventing the internal steel core from buckling. PwC building is designed to yield the piece of flat steel inside the brace, which absorbs the energy of an earthquake; the concrete case retains the plate and stops it from seriously deforming. The braces can be readily removed and replaced for ease of repairs.

Figure 6. PwC Centre: (a) Architecture view (Courtesy of Beca); (b) Close-up view of bracing (Courtesy of Steel Construction New Zealand)
